BEML D355 DOZER BLADE REPAIR AT CENTURY CEMENT

Technical Details:

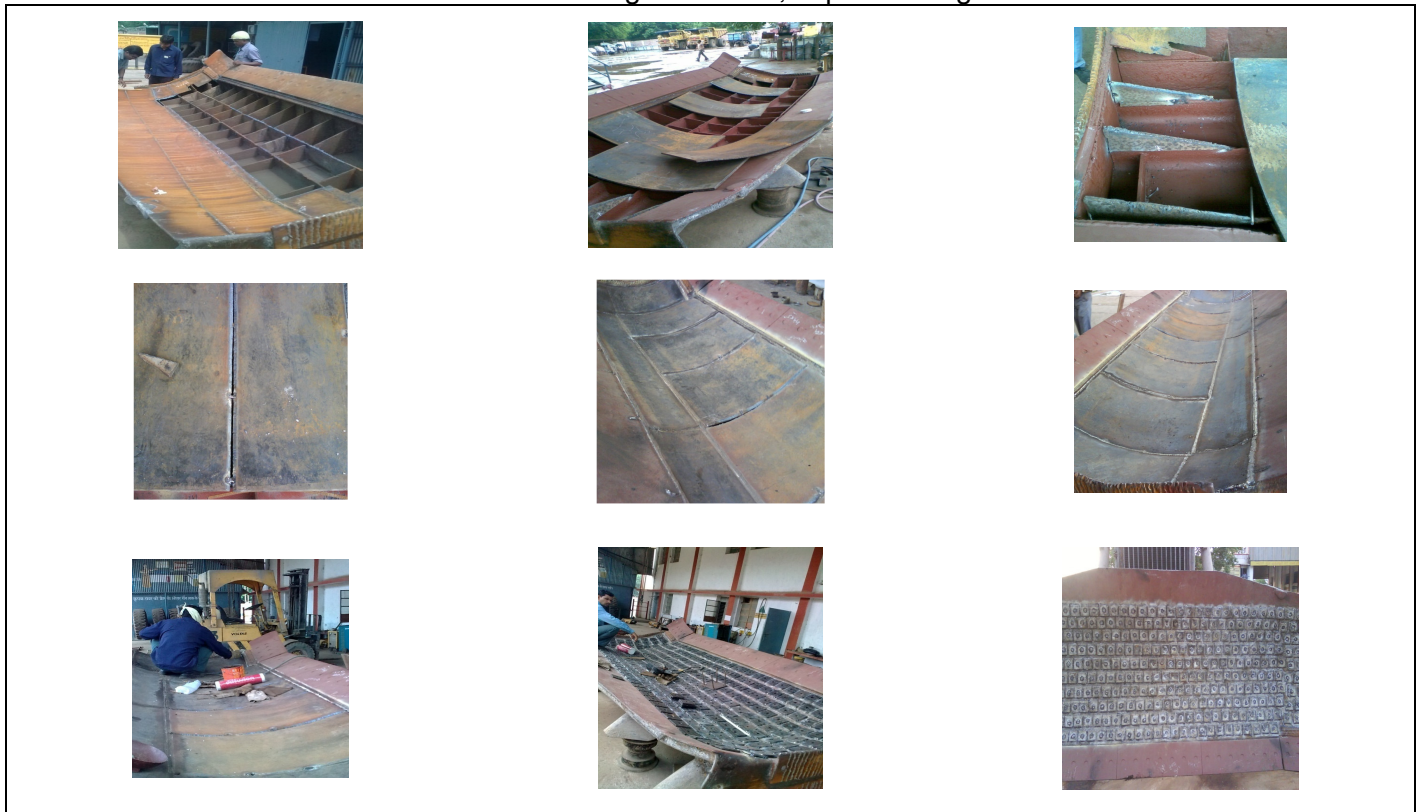
- The dozer blade plate hard faced with electrodes, was worn out badly and deformed in shape. Patch up was also done at several places which had given off.
- The worn out hard faced plates were cut off by gas cutting & gauging process.
- Profile template was made & 12mm M.S. plates were bent to profile and cut in 12 no. of pieces.
- The lost sections from rib frame were rebuilt to strengthen the structure.
- All the plates were aligned and welded after proper edge preparation.
- All the plates were aligned and welded after proper edge preparation.
- Wear plates (Diffplate AR) were arranged & welded to repaired dozer blade upto cutting edge area.
- All the welding lines and plug welded area were hard faced using Abrocar 84.

Total Quantity Of Electrodes : Diffusaloy 6180 (3.15+4.00) :- 105 kgs,
 Abrocar 84 (4.00mm) :- 40 kgs.
 Supergouge (4.00mm) :- 20 Kgs.
 Diffplate AR (100x100x10mm) :- 330 Nos.
